Home Inspection Report

Prepared for:
Ms & Mr Homebuyer

at:
1029 Main Street
Somewhere, B.C.

May 28, 2011

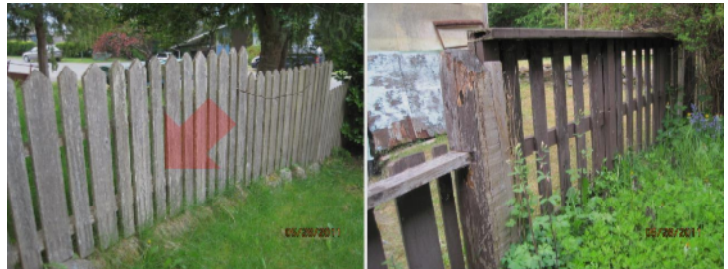
Fences

Wood, Suggest painting or staining wooden fencing to extend life. Hedging - Suggest trimming to improve view.

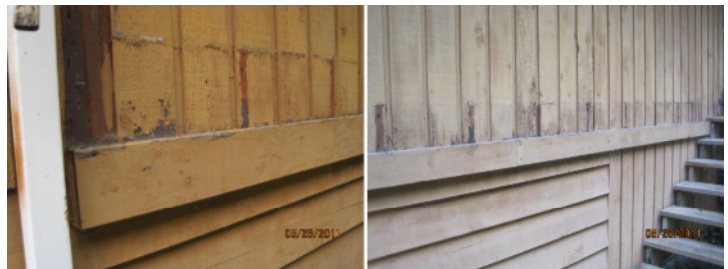
Painted Finishes

- Siding, Trim, Soffits, Doors, Windows, Decks, Painting/staining recommended to extend life.

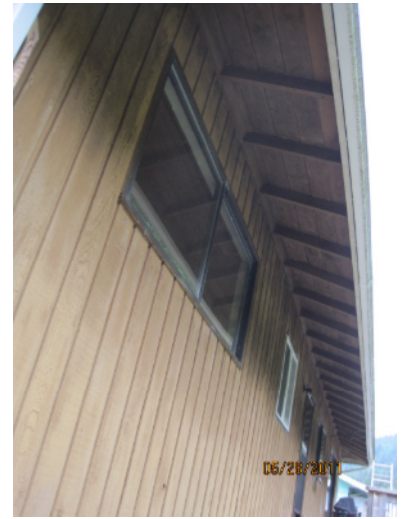
Soffit

Closed, Wood, Suggest adding soffit vents as needed.

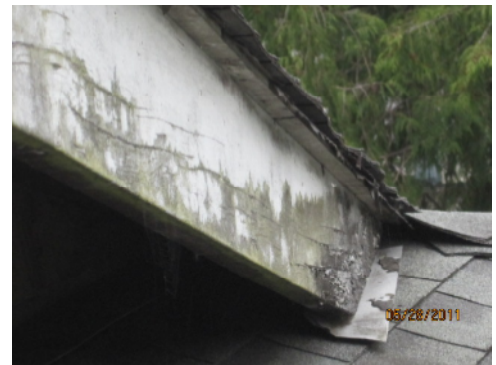
Fascia/Gable Trim

Suggest repairing/repainting/staining exposed parts of fascia.

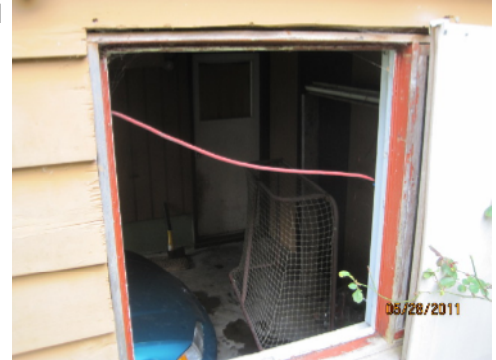
Material

- Metal, Wood, Vinyl, mechanisms damaged / inoperative, Cracked / broken / missing glass - carport.

Suggest cleaning tracks on all windows and sliding doors with dish soap and warm water to inhibit mould build up.

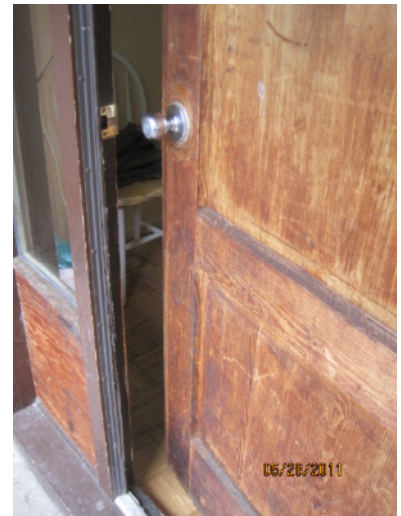
Main Entry

- Wood. Suggest repair/replace weather stripping, Suggest re sanding/ refinishing door to extend life.

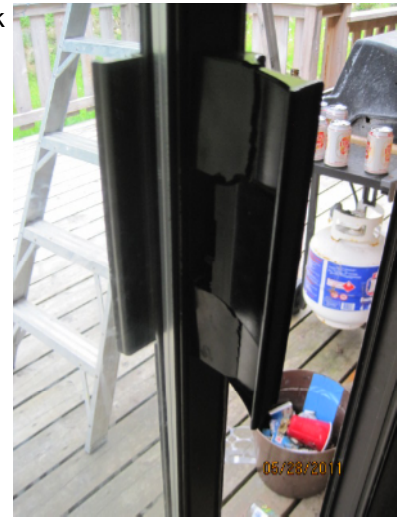
Sliding Doors

Metal, Double glazed, Lock Set in need of repair. Suggest cleaning tracks with dish soap and warm water to inhibit mould build up.

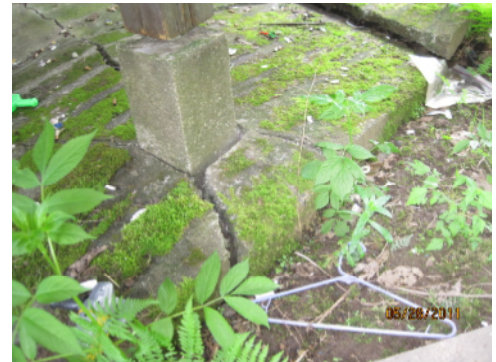
Porch/Deck

Wood. Footing seem stable, but slab/patio under deck has cracked dramatically - Suggest removal (as it is separate from footings)

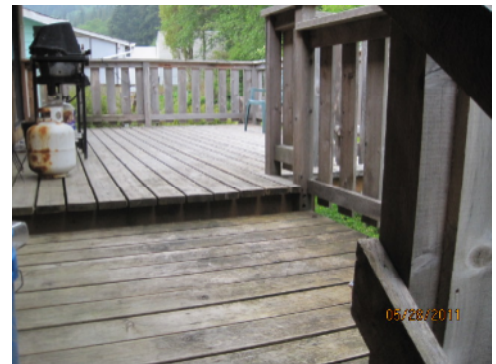
Deck Surface

Wood, Suggest refinishing all surfaces (decking, rails and stairs) to extend life.

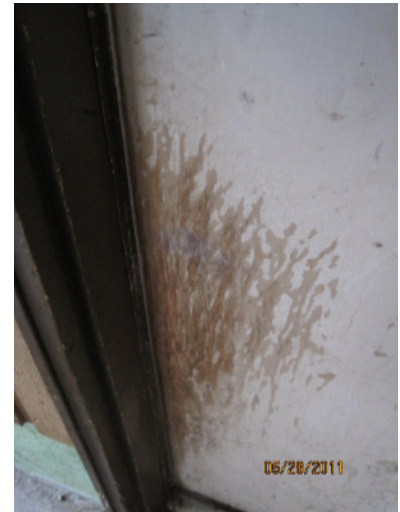
- Size / Style** 1 car, Carport .
- Roof Style** Gable, Roof part of main house construction.
- Roof Material** Asphalt Shingle, Roof part of main house construction.
- Roof Structure** Roof part of main house construction.
- Structure** Post & Beam.
- Exterior Siding & Trim** Wood, Part of main house.
- Foundation** Minor cracks - suggest monitoring to see if they grow.
- Floor** Concrete.
- Carport Service Door** into carport storage room at rear, Wood, Hollow core.
- Carport House Door** Hollow core, Glazed, Suggest replace / install weather stripping, Suggest re sanding/refinishing door to extend life. Suggest adding door closer hardware

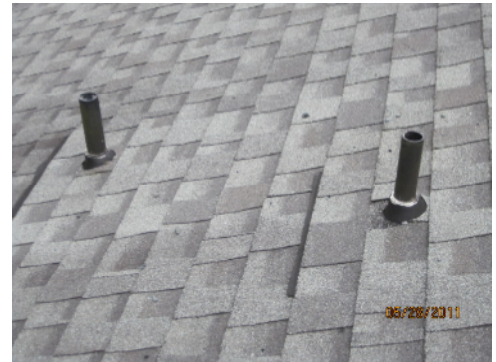
Plumbing Vent

Caps missing - suggest adding.

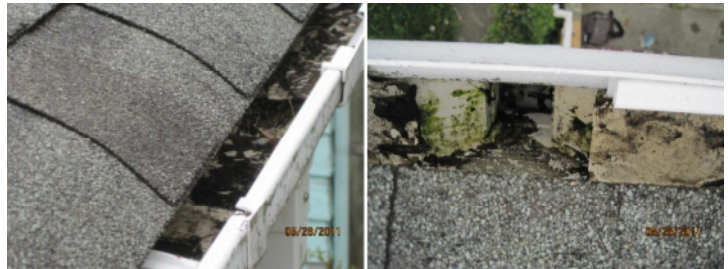
Roof Drains

Suggest add/replace strainer baskets.

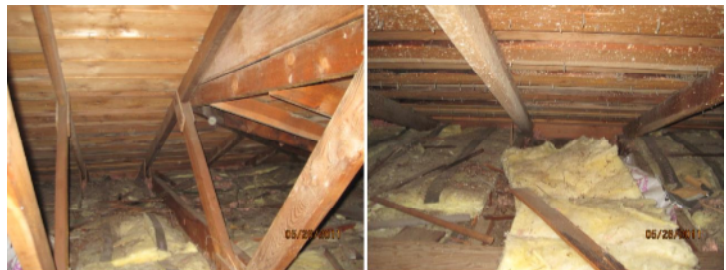
Attic

- Roof vents, Gable vents, Suggest adding ventilation at soffits, Suggest adding baffles between trusses at soffit to ensure adequate ventilation. Baffles will prevent insulation from blocking soffit ventilation pathways.
- Batt, Fiberglass, Poly vapour barrier, Estimated R value: 24 Suggest improvement to current standards (R40)
- Moisture Evidence

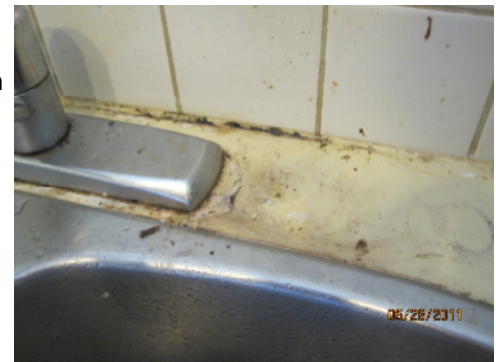
Sink

Double basin, Stainless steel. Minor chip, scratch or damage. Some mould visible around faucet.

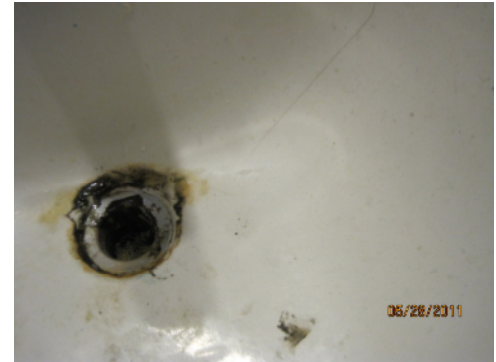
With vanity,
Chipped/cracked,
Slow drain.

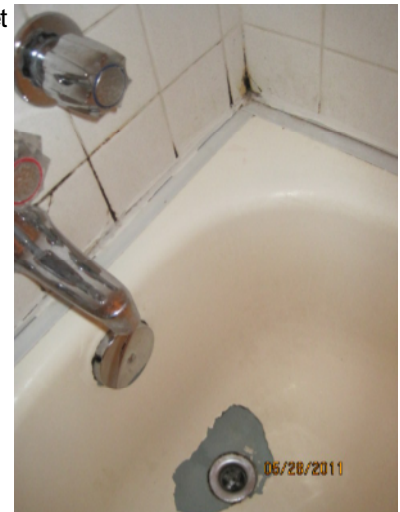
Tub/Enclosure

With shower - unable to get tap to work (only shower operating) suggest further investigation, Enamel, Chipped, Tile surround - Mold / mildew,

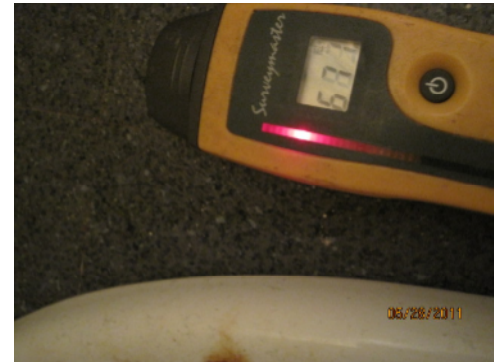
Moisture meter readings: 68%. Meter readings indicate possible leakage. Suggest further investigation.

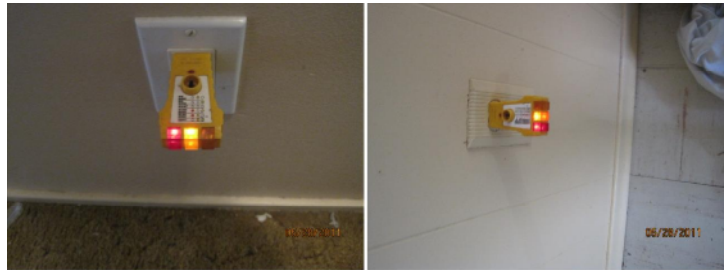
Circuitry

Copper Grounded, Some ungrounded outlets noted - upgrade to grounded, Replace worn or broken outlet receptacles or switches, Correct outlets with reverse polarity.
